## Maids Moreton Conservation Area

*Designated by the Council 8th July 2009  
following public consultation*

# Maids Moreton Conservation Area

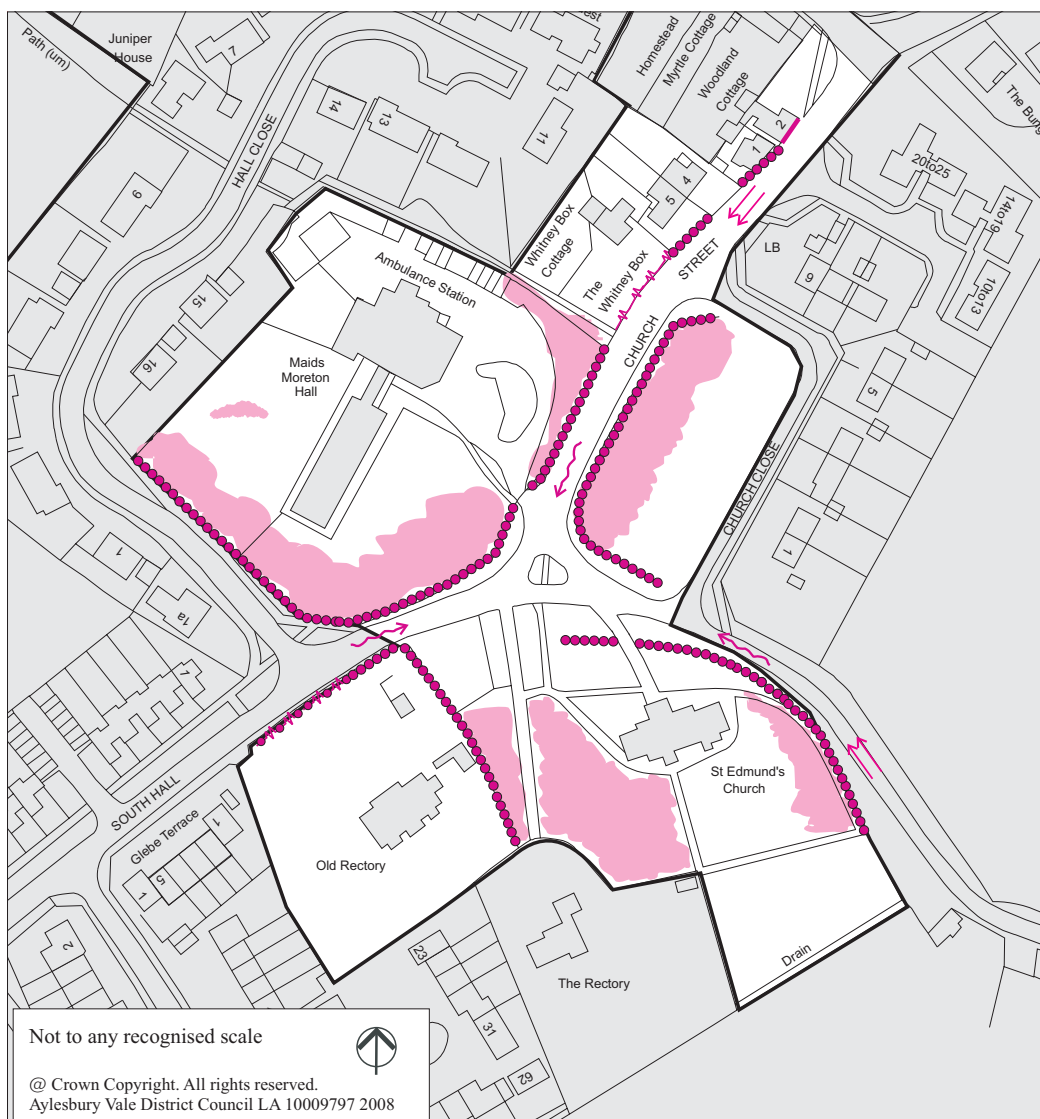
Loss of enclosure	<u>Visually important boundaries</u>	
 	Indicating rise in ground level	 	Walls, fences, railings
 	Strong building line providing enclosure	 	Hedges
 	Trees providing enclosure	 	Hedges, with railings or walls
 	Conservation Area boundary

- Identity Area 1 is concentrated around a roughly T-shaped junction formed by Church Street, South Hall and Mill Lane. The junction of the three roads forms a small grassed island within the carriageway.
- South Hall leads in a roughly north-east to south-west direction out of the Conservation Area. It is largely characterised by modern development.
- Church Street extends in a south-west to north-east direction towards the junction with Main Street. The section of Church Street contained within the Conservation Area is relatively short. It is fairly consistent in width, broadening slightly at road junctions. There is a gentle bend in the road close to the junction with Church Close.
- Pavements in this area are restricted to the north-western side of Church Street and the south-eastern side of Church Close.

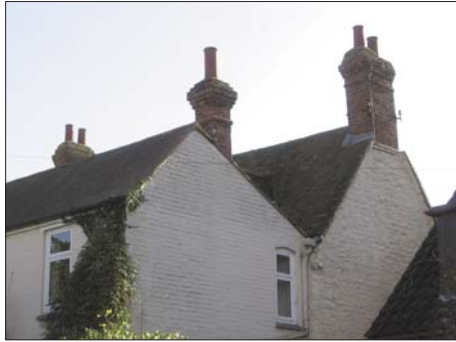
*Tiled gable roof*

There is a mixture of gable, half-hipped and hipped roof forms found on historic buildings within Maids Moreton.

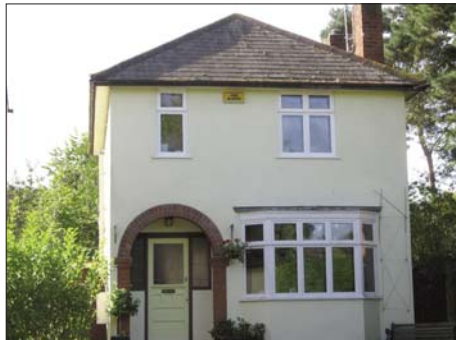
*Hipped roof*

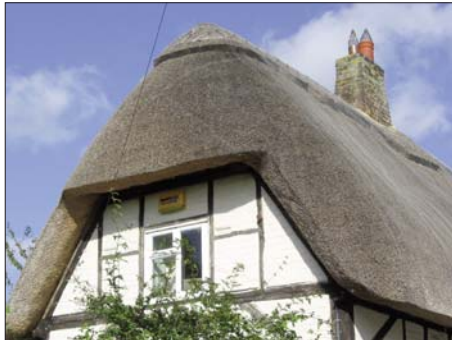
*Half hipped roof*

A number of the thatched buildings have hipped or half hipped elements to their roofs.

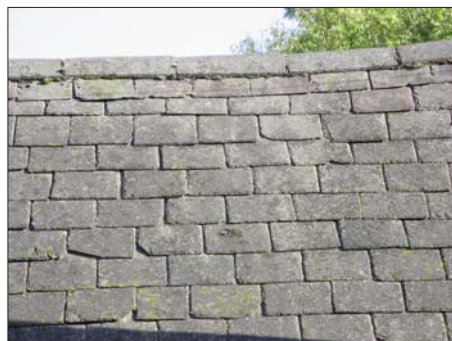
*Slate roof*

The use of natural slate as a roofing material is generally confined to 19th century buildings, agricultural, or former agricultural buildings (Outbuildings at The Old Manor House), or to historic buildings where the roof has been altered (The Whitney Box).

Slate is often not as richly textured as tile. Slate tends to be thinner and so does not create the same shadows and lines as a tiled roof. However, natural variations in colour between slates can create interest, especially on large roof planes. When slate is wet it becomes much darker in colour and gains an attractive sheen. In the main those roofs covered in slate are shallow in pitch and are typically gabled or hipped in form.

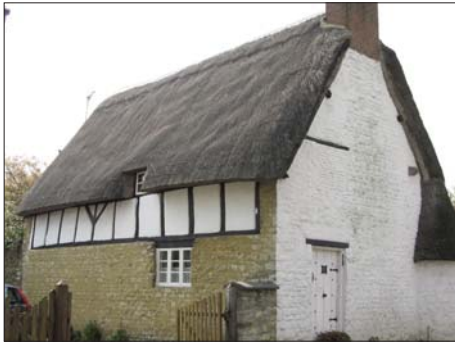
*Thatched roof with flush ridge*

A number of thatch properties still survive in Maids Moreton. Traditionally, buildings in this area would have been thatched in long-straw and later combed-wheat reed with flush ridges. This traditional form of thatching creates soft rounded outlines to roofs which contrast with the sharp clipped appearance of roofs laid in water-reed, which is not traditional to the area. The re-thatching of long straw or combed wheat reed roofs with water reed usually involves removing all of the old thatch and this can lead to the loss of important historic material.

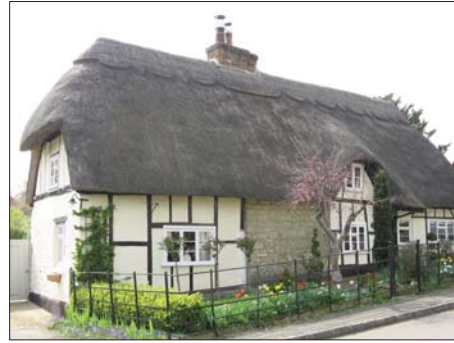
*Thatched roof with block ridge*

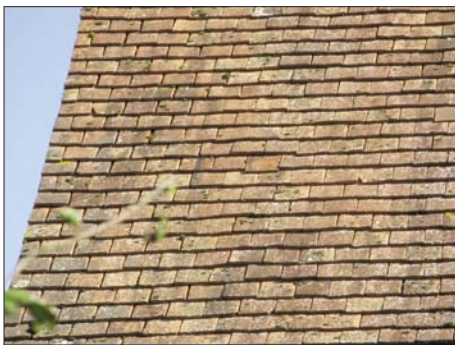
*Traditional tiled roof*

Many historic buildings in Maids Moreton are roofed in tile. Unfortunately, a number of tiled roofs have been re-laid in modern machine made tiles which lack the characteristic texture, cambered profile and reddish, orange colour traditional to the village.

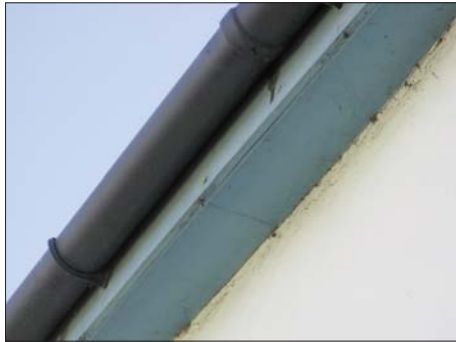
*Boxed eaves*

The treatment of the eaves and verges of roofs of historic buildings within Maids Moreton is generally plain and simple. The majority of buildings have boxed eaves. However, some buildings have exposed rafter feet and there are several examples of dentilated brickwork at eaves level. This is a decorative effect created by the projection of alternate brick headers to create a tooth like pattern. Verges are generally plain although the 19th century Old School House has painted decorative verge boards.

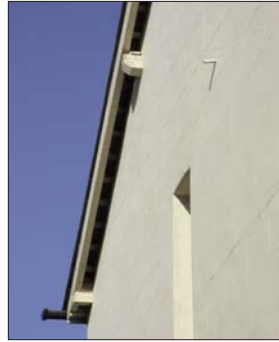
*Exposed rafter feet*

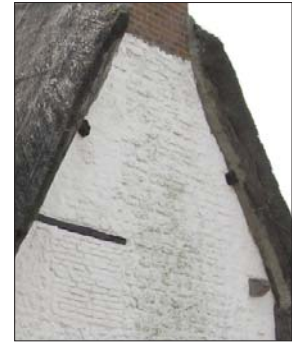
*Dentilated brick eaves*

More subtle examples of the use of brick to create decorative effects are the dog-toothed patterning of dentillated brickwork found at eaves level on several brick buildings within the village.

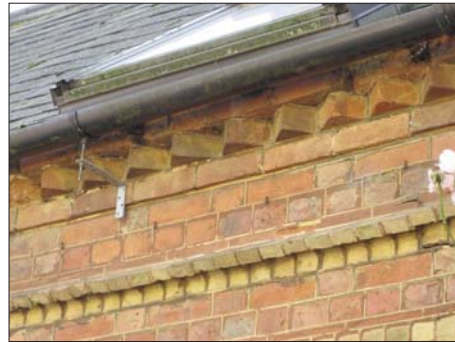
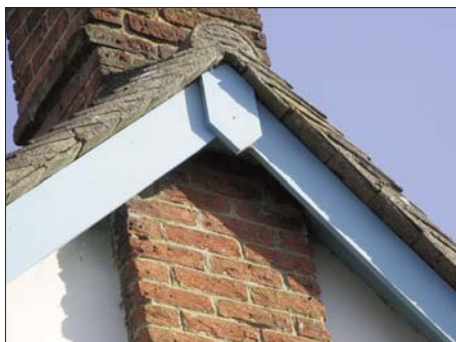
*Wooden verges*

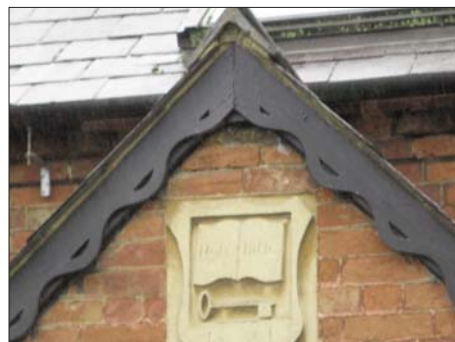
*Painted decorative vergeboards  
Old School*

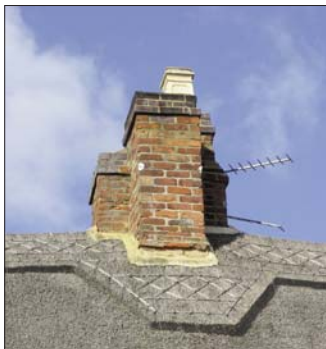
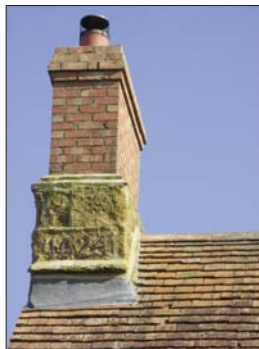
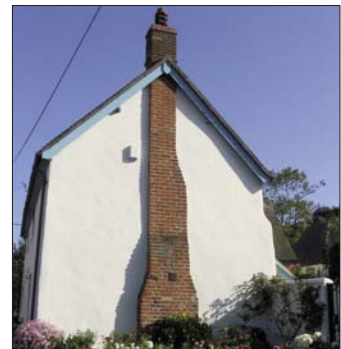
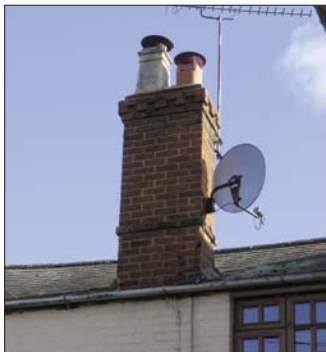
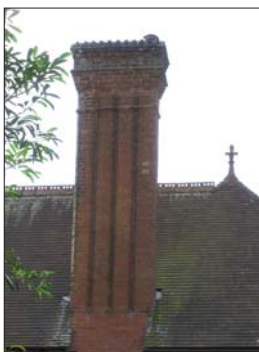
### Examples of chimneys found in Maids Moreton

There are examples of gable end and mid ridge chimneys positioned within the roof plane and external stacks within the village. The majority of the chimneys in the village are constructed of brick and are rectangular in form and relatively plain in detail.

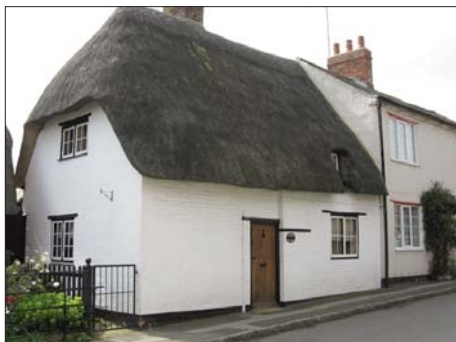
The majority of the panels between the timber elements have been infilled with brick. In some cases the brick infill panels are hidden beneath render and paint which creates a strong visual contrast between the painted surface and the blackened timber elements.

*Painted brick, Myrtle Cottage*

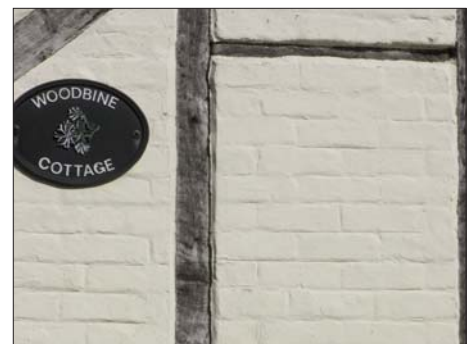
*Painted brick infill panels*

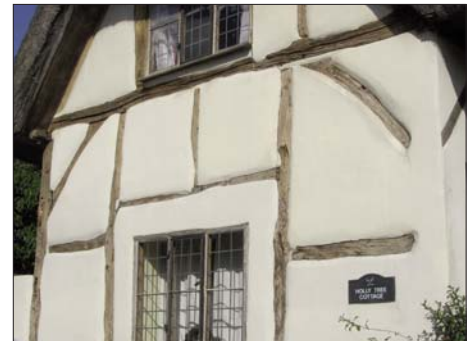
*Rendered infill panels*

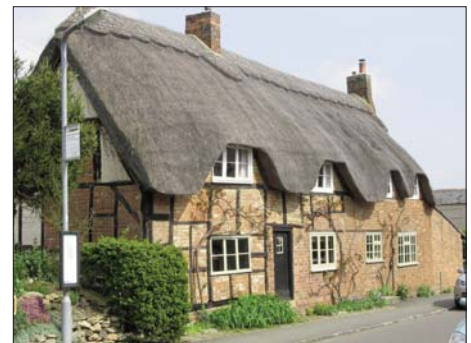
*Brick infill, Chestnut Cottage*

Vitrified bricks are also used within the village to create decorative effects. Examples include Chestnut Cottage on Main Street where the blue colours of vitrified bricks have been used randomly in combination with the normal red bricks to create wall surfaces of contrasting colours.

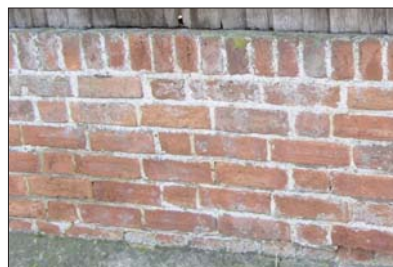
The majority of brick boundary walls in the village are laid in a Flemish garden-wall (Sussex) bond.

*Flemish garden wall bond*

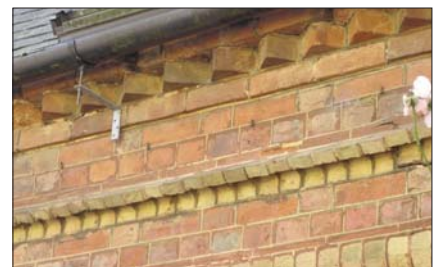
*Dentillated brickwork*

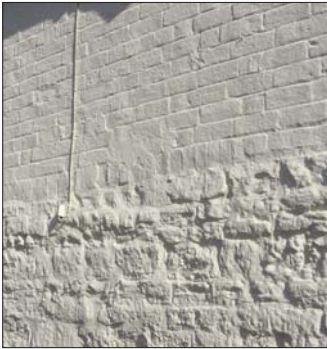
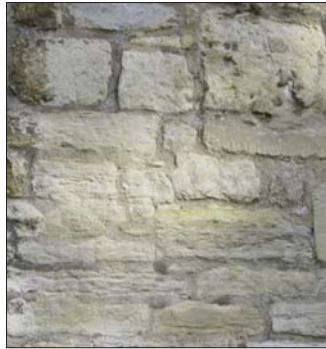
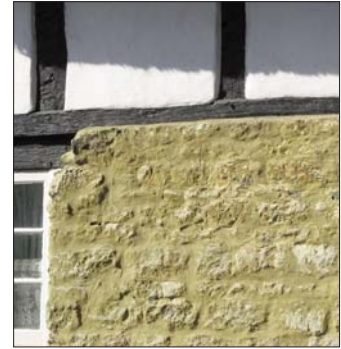
### Examples of stone in Maids Moreton

Rubblestone is used quite extensively in the construction of historic buildings in Maids Moreton. The most important building in the village, the Church of St. Edmund is constructed of rubblestone, as are other prominent buildings such as Manor Farmhouse, The Old House and Upper Farmhouse. A number of timber framed buildings within the village sit on rubblestone plinths and rubblestone is also found on gables. In the case of Sideways Cottage located on Main Street, the ground floor and gables are constructed of rubblestone with timber frame and plaster infill panels forming the first floor. In all cases rubblestone used to construct buildings in Maids Moreton is coursed.

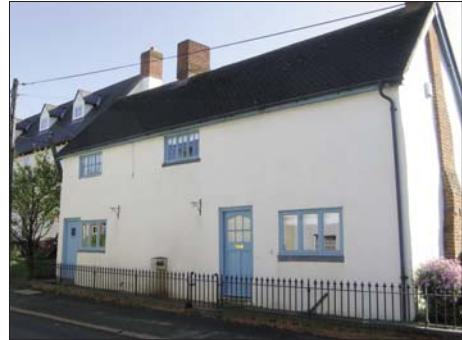
With some exceptions, the buildings within Maids Moreton dating from or post the 19th century tend to present relatively regular fenestration patterns to the street, while those pre-19th century are generally more haphazard in the position of their windows and doors.

*Irregular fenestration, Yew Trees*

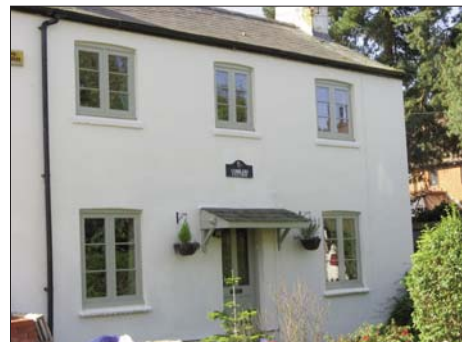
*Regular fenestration, Cobblers Cottage*

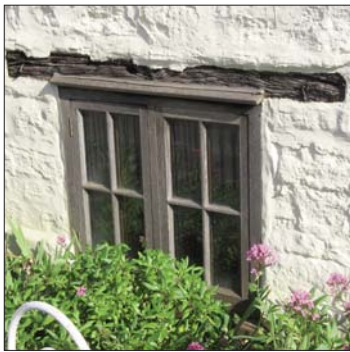
Where original openings survive, they reveal that the majority of the historic windows within the village sit beneath simple timber lintels (often disguised beneath render).

*Timber Lintel*

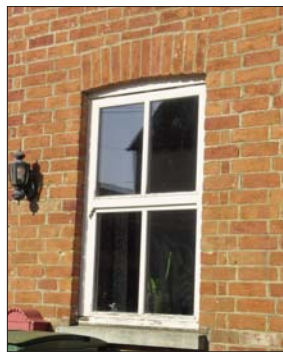
There are examples of segmental brick arches within the village which are generally found on buildings of late 19th or early 20th century date. In some cases these brick arches have been painted.

*Brick segmental arch*

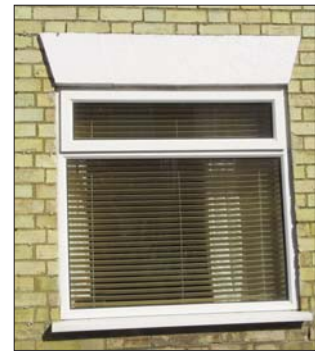
*Painted lintel*

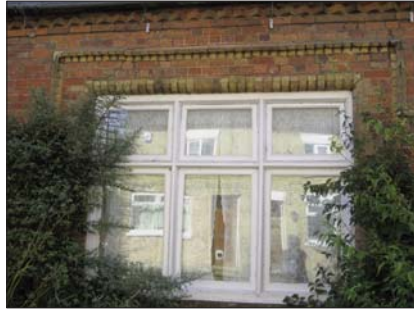
Brick hood mould

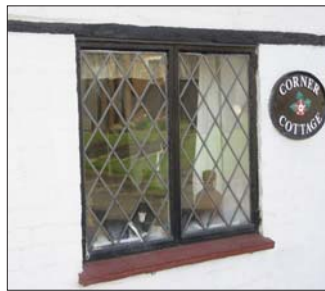
Leaded windows

The majority of the surviving historic windows are wooden although there are limited examples of leaded windows. Where windows are timber, they tend to be painted white rather than stained.

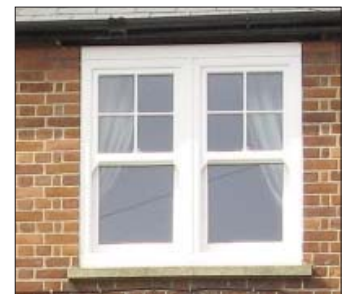
The majority of the surviving historic windows in Maids Moreton are casement windows; although there are a number of examples of sash windows. Sash windows are windows in which the glazed units are contained in frames which can be raised and lowered vertically along grooves or slid from side to side. All the sashes in Maids Moreton open and shut vertically. Wooden sash windows vary in terms of their proportions, the number of panes and the thickness and detailing of their glazing bars.

Sash window

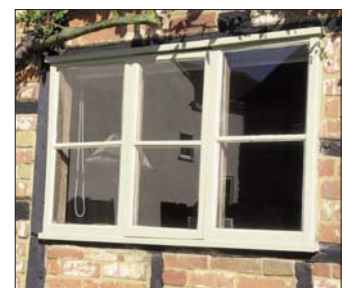
Casement window

Casement windows are windows in which the glazed units are contained in a frame which is hung from hinges. Wooden casement windows vary in terms of their proportions, the number of panes and whether the lights are opening or fixed.

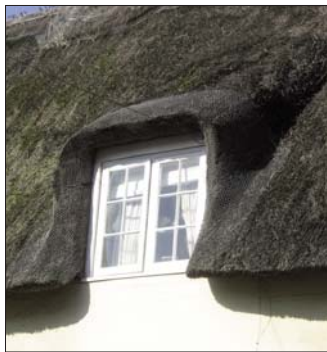
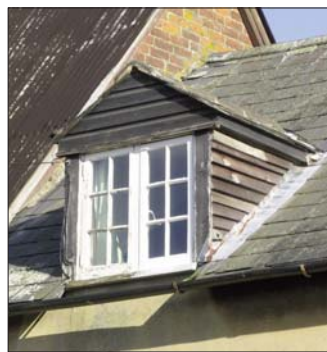
### Examples of dormer windows

A number of the historic buildings, in particular the thatched or formerly thatched buildings have dormer windows within their roof planes or at the eaves line. The majority of dormers are swept or eyebrow in form.

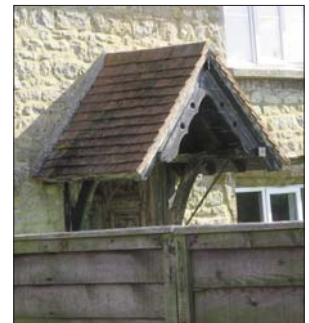
Porches are not a typical characteristic of historic buildings in Maids Moreton but there are occasional examples.

*Porch at Upper Farm*

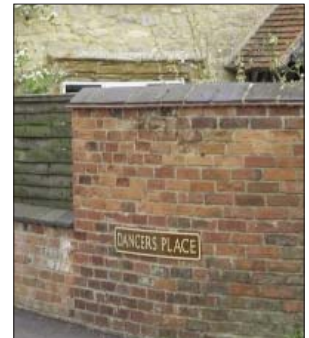
Where walls do exist they are typically low, constructed of brick or stone or a combination of the two. Important examples of more substantial stone walls survive at Maids Moreton Hall and The Old Manor Farmhouse. Stone walls tend to be coursed. Brick walls within the village tend to be constructed in a Flemish Garden Wall bond (also called Sussex bond consisting of one header followed by three stretchers). Neither brick or stone walls within the village are typically buttressed. Examples can be found of walls being capped in both brick and stone

Brick wall

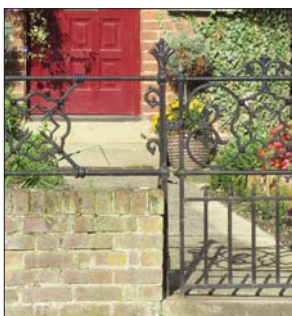
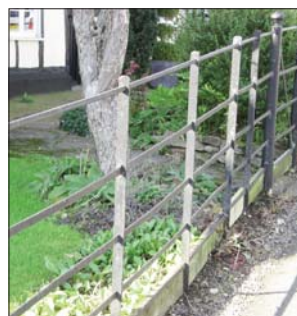
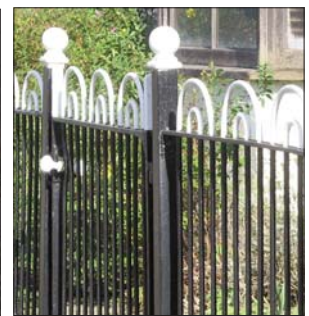
### Examples of railings in Maids Moreton

Sections of railing and fencing are also found throughout the village. Some sections of railings sit on dwarf brick walls, other sections are set straight into the ground.

There is a mixture of relatively plain and more ornate railings surviving in the village. Of particular note are the 19th century railings in front The Old House on Main Street. Plainer designs include the estate railings outside Woodland Cottage and the hoop railings at 3 Old Bakery Cottage.

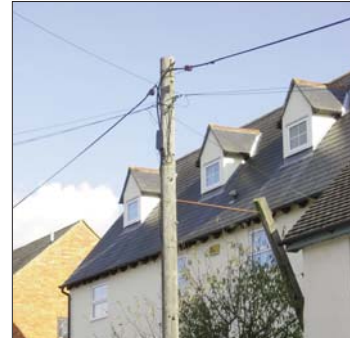
*Overhead wires*

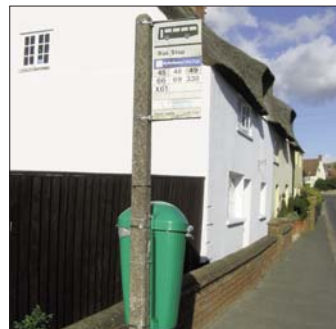
*Street furniture*
