Maids Moreton Conservation Area

*Designated by the Council 8th July 2009
following public consultation*

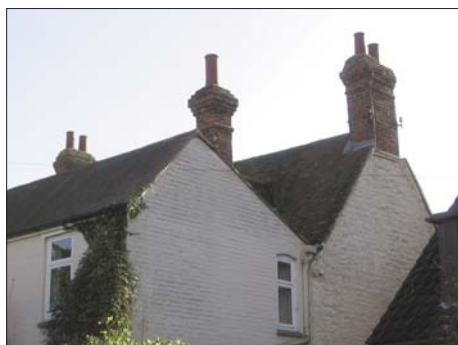
Tiled gable roof

There is a mixture of gable, half-hipped and hipped roof forms found on historic buildings within Maids Moreton.

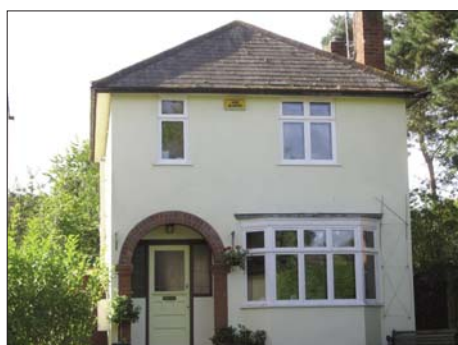
Hipped roof

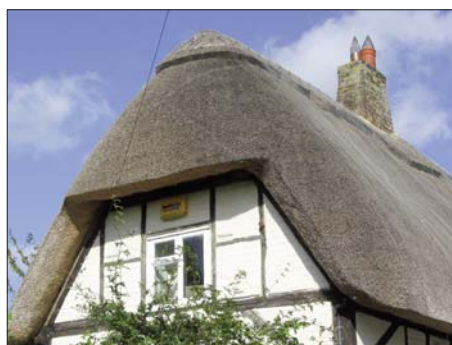
Half hipped roof

A number of the thatched buildings have hipped or half hipped elements to their roofs.

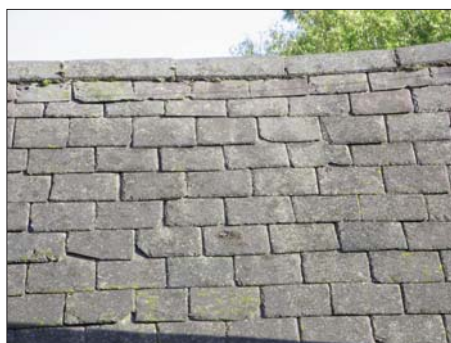
Slate roof

The pitch of roofs varies according to the material covering them or which formerly covered them. Roofs covered in thatch tend to have very steep pitches of around 55° , tiled roofs are traditionally pitched at approximately 45° . Tiled roofs with pitches approaching 55° such as The Old Bakery, Duck Lake and Scott's Farmhouse, Towcester Road may indicate that these buildings were formerly thatched. Slate roofs are relatively shallow in pitch, commonly ranging between 30° and 40° .

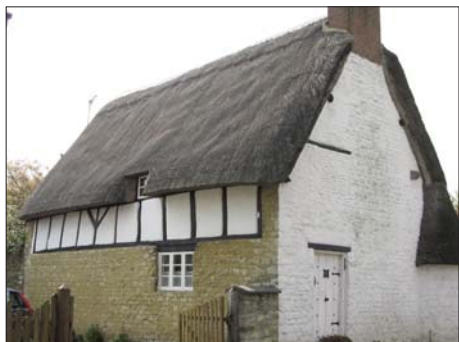
Thatched roof with flush ridge

A number of thatch properties still survive in Maids Moreton. Traditionally, buildings in this area would have been thatched in long-straw and later combed-wheat reed with flush ridges. This traditional form of thatching creates soft rounded outlines to roofs which contrast with the sharp clipped appearance of roofs laid in water-reed, which is not traditional to the area. The re-thatching of long straw or combed wheat reed roofs with water reed usually involves removing all of the old thatch and this can lead to the loss of important historic material.

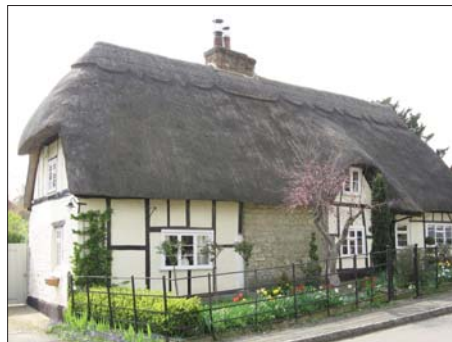
Thatched roof with block ridge

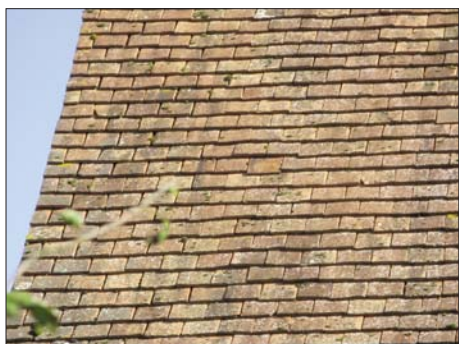
Traditional tiled roof

Many historic buildings in Maids Moreton are roofed in tile. Unfortunately, a number of tiled roofs have been re-laid in modern machine made tiles which lack the characteristic texture, cambered profile and red, orange colour traditional to the village.

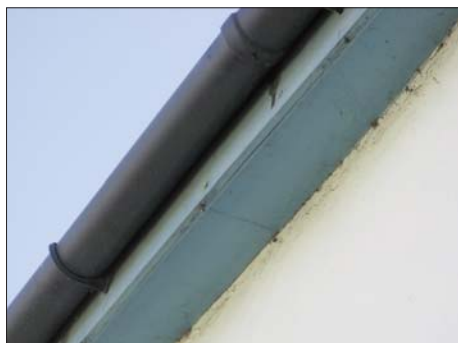
Boxed eaves

The treatment of the eaves and verges of roofs of historic buildings within Maids Moreton is generally plain and simple. The majority of buildings have boxed eaves. However, some buildings have exposed rafter feet and there are several examples of dentilated brickwork at eaves level. This is a decorative effect created by the projection of alternate brick headers to create a tooth like pattern. Verges are generally plain although the 19th century Old School House has painted decorative verge boards.

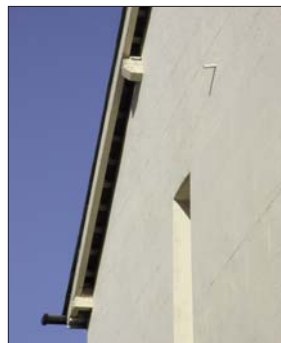
Exposed rafter feet

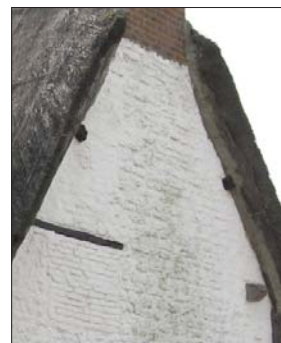
Dentilated brick eaves

More subtle examples of the use of brick to create decorative effects are the dog-toothed patterning of dentillated brickwork found at eaves level on several brick buildings within the village.

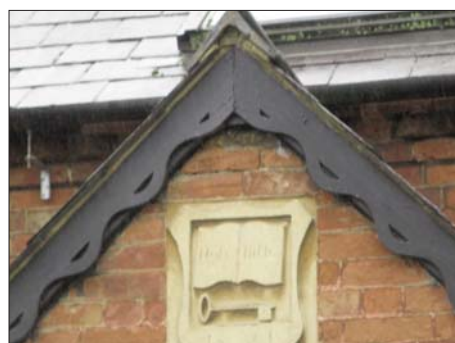
*Painted decorative vergeboards
Old School*

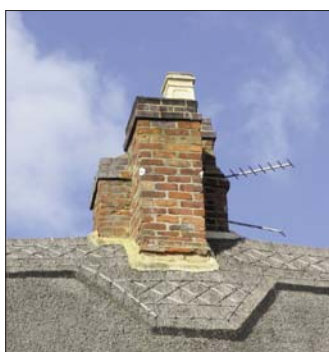
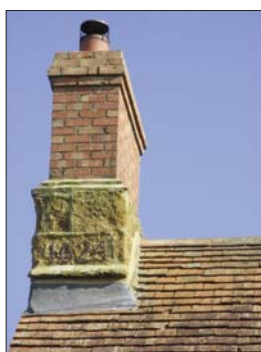
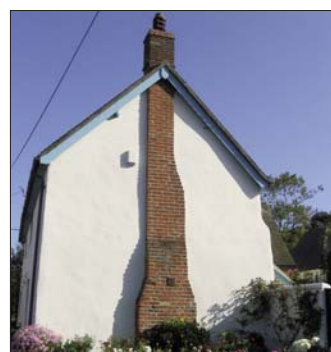
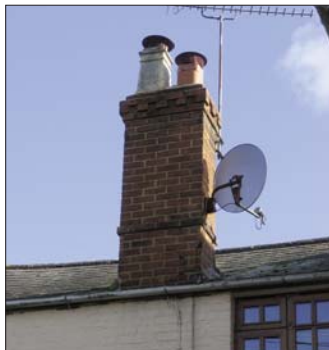
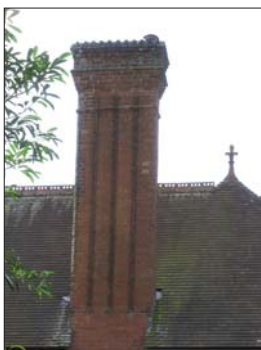
Examples of chimneys found in Maids Moreton

There are examples of gable end and mid ridge chimneys positioned within the roof plane and external stacks within the village. The majority of the chimneys in the village are constructed of brick and are rectangular in form and relatively plain in detail.

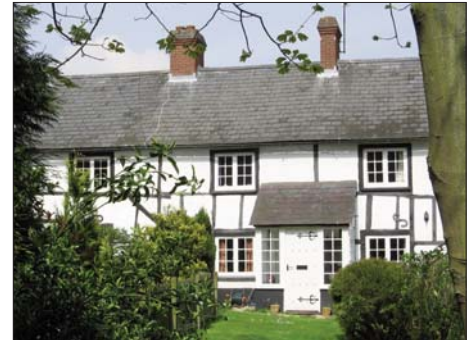
Timber frame, Whitney Box Cottage

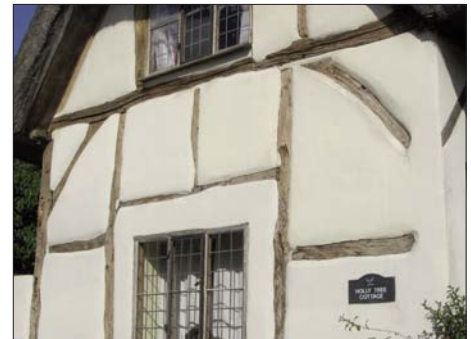
Rendered infill panels

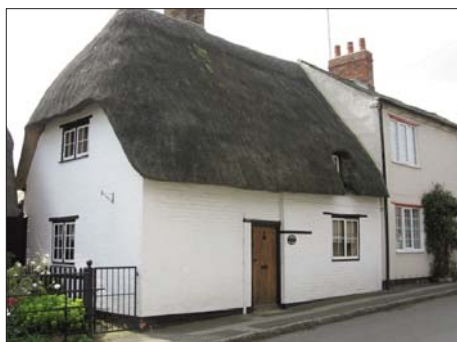
Painted brick, Myrtle Cottage

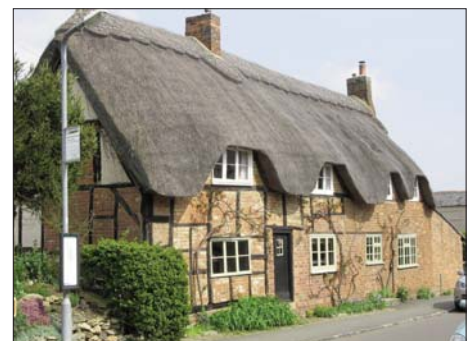
Brick infill, Chestnut Cottage

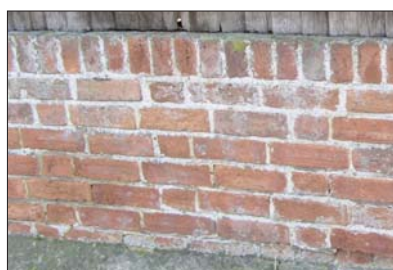
Flemish garden wall bond

The majority of the bricks used in the construction of historic buildings in Maids Moreton are laid in a Flemish bond.

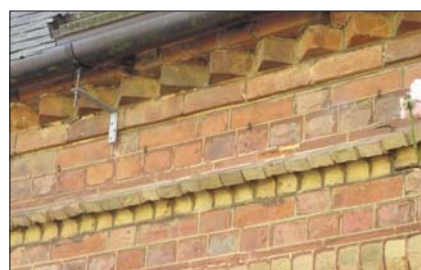
Dentillated brickwork

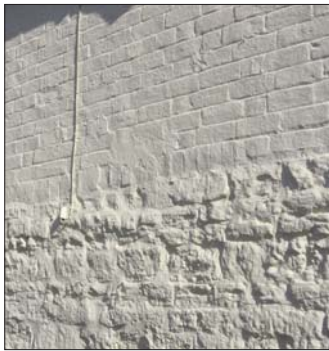
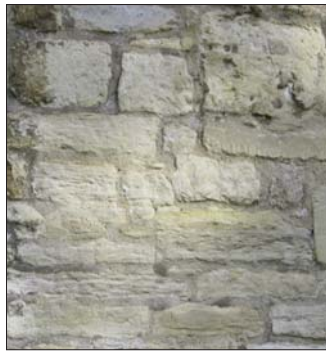
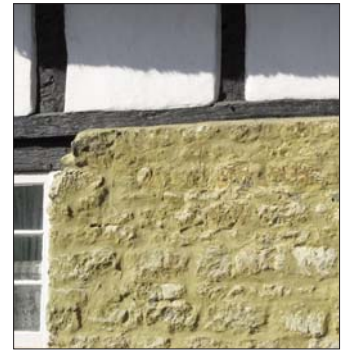
Examples of stone in Maids Moreton

Rubblestone is used quite extensively in the construction of historic buildings in Maids Moreton. The most important building in the village, the Church of St. Edmund is constructed of rubblestone, as are other prominent buildings such as Manor Farmhouse, The Old House and Upper Farmhouse. A number of timber framed buildings within the village sit on rubblestone plinths and rubblestone is also found on gables. In the case of Sideways Cottage located on Main Street, the ground floor and gables are constructed of rubblestone with timber frame and plaster infill panels forming the first floor. In all cases rubblestone used to construct buildings in Maids Moreton is coursed.

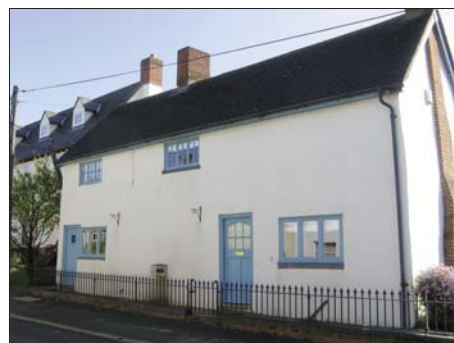
Irregular fenestration, Yew Trees

With some exceptions, the buildings within Maids Moreton dating from or post the 19th century tend to present relatively regular fenestration patterns to the street, while those pre-19th century are generally more haphazard in the position of their windows and doors.

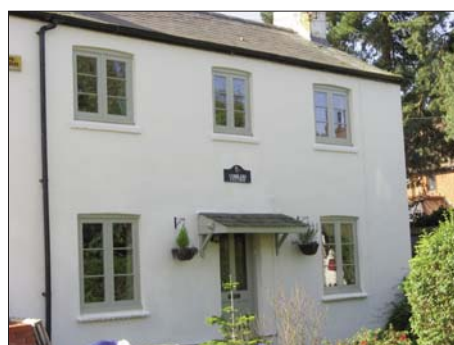
Regular fenestration, Cobblers Cottage

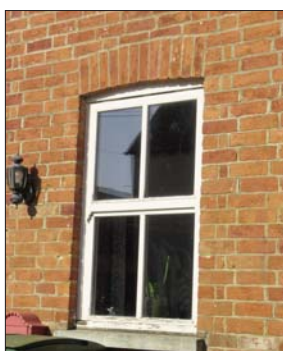
Brick segmental arch

There are examples of segmental brick arches within the village which are generally found on buildings of late 19th or early 20th century date. In some cases these brick arches have been painted.

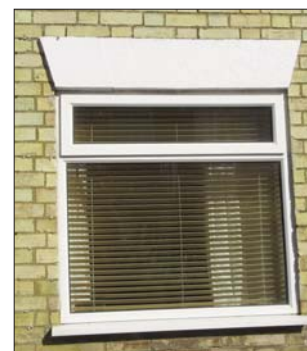
Painted lintel

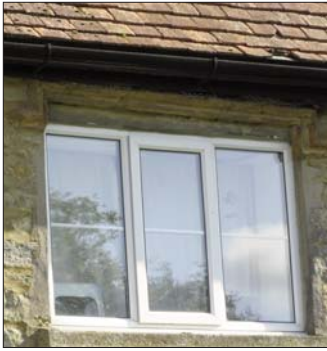
Stone hood mould

The use of stone for lintels is limited, the most notable examples are the flat stone hoodmoulds above the ground floor windows at Upper Farmhouse and The Old School, the stone lintels above openings at The Old Rectory and the lintels and decorative stone surrounds at Maids Moreton Hall. In the last three examples, the buff colour of the stone contrasts with the red/orange of the brickwork creating a striking visual effect.

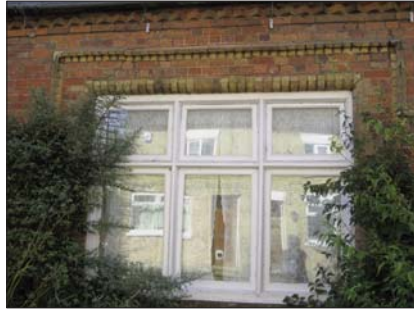
Brick hood mould

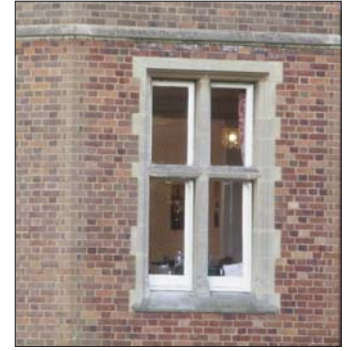
Mullion and transom window

There are a small number of windows within historic buildings which have mullions and transoms. A mullion is a pier that divides the lights of a window vertically. A transom is a bar which divides the window lights vertically. Mullion windows are found at Manor Farmhouse and evidence of them survives at Upper Farmhouse. Mullion and transom windows were a popular form of window during the 19th century and can be found enlivening the elevations of Maids Moreton Hall, The Old Rectory and The Old School.

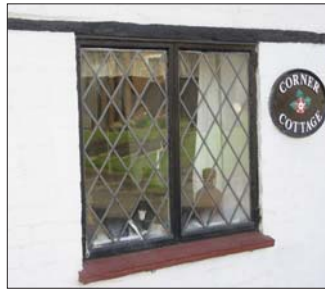
Leaded windows

The majority of the surviving historic windows are wooden although there are limited examples of leaded windows. Where windows are timber, they tend to be painted white rather than stained.

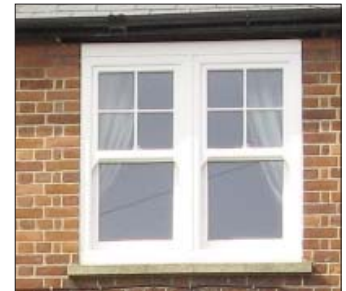
Sash window

The majority of the surviving historic windows in Maids Moreton are casement windows; although there are a number of examples of sash windows. Sash windows are windows in which the glazed units are contained in frames which can be raised and lowered vertically along grooves or slid from side to side. All the sashes in Maids Moreton open and shut vertically. Wooden sash windows vary in terms of their proportions, the number of panes and the thickness and detailing of their glazing bars.

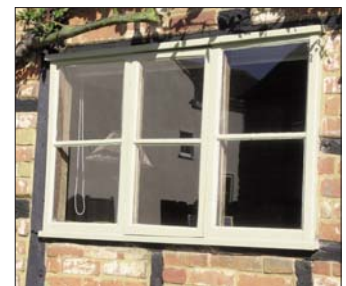
Casement window

Casement windows are windows in which the glazed units are contained in a frame which is hung from hinges. Wooden casement windows vary in terms of their proportions, the number of panes and whether the lights are opening or fixed.

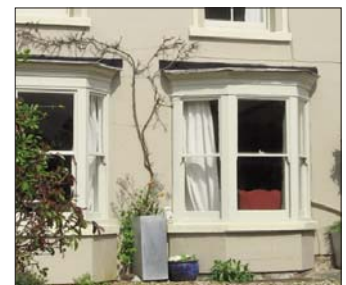
Bay window

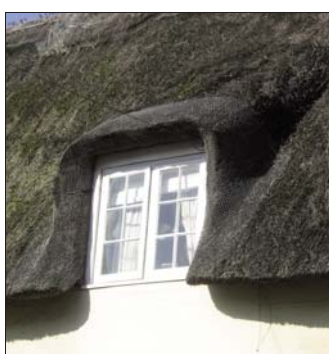
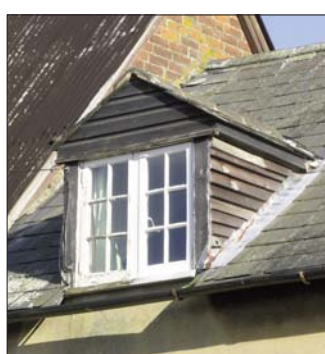
Examples of dormer windows

A number of the historic buildings, in particular the thatched or formerly thatched buildings have dormer windows within their roof planes or at the eaves line. The majority of dormers are swept or eyebrow in form.

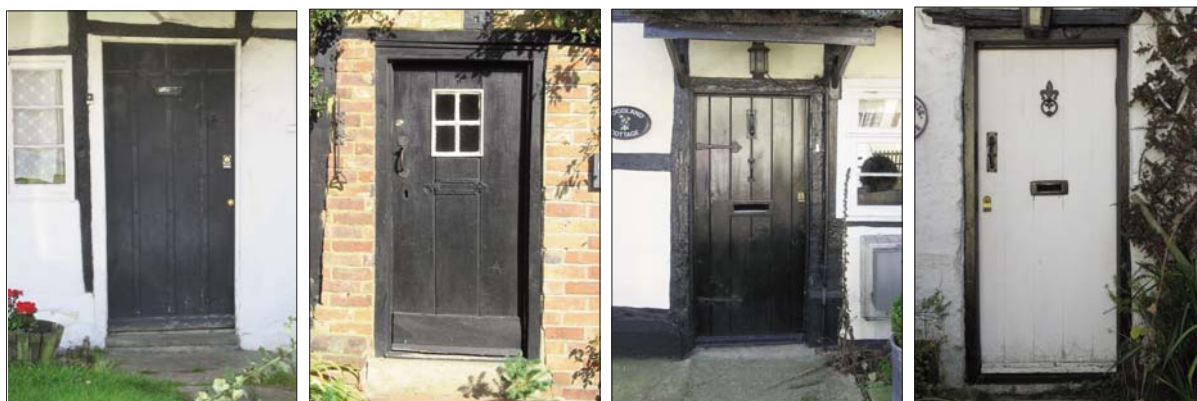
Examples of doors in Maids Moreton

Despite the replacement of a number of historic doors on older properties within the village several varied, but fine examples do survive.

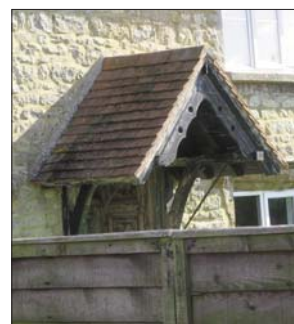
Porch at Upper Farm

Porches are not a typical characteristic of historic buildings in Maids Moreton but there are occasional examples.

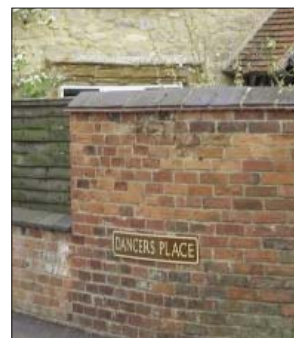
Brick wall

Where walls do exist they are typically low, constructed of brick or stone or a combination of the two. Important examples of more substantial stone walls survive at Maids Moreton Hall and The Old Manor Farmhouse. Stone walls tend to be coursed. Brick walls within the village tend to be constructed in a Flemish Garden Wall bond (also called Sussex bond consisting of one header followed by three stretchers). Neither brick or stone walls within the village are typically buttressed. Examples can be found of walls being capped in both brick and stone

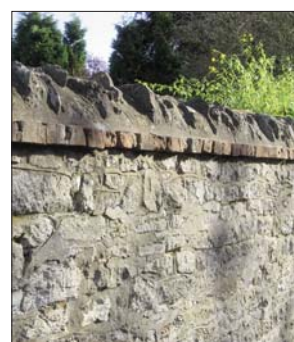
Stone capping

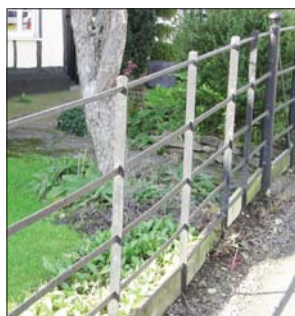
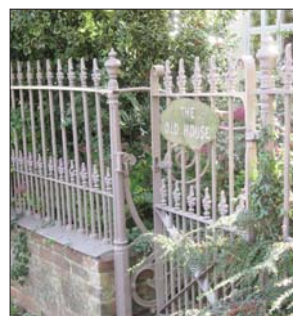
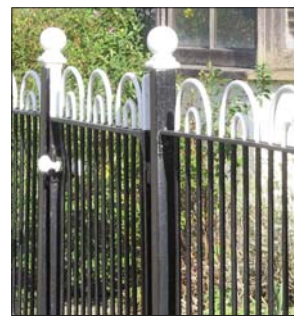
Examples of railings in Maids Moreton

There is a mixture of relatively plain and more ornate railings surviving in the village. Of particular note are the 19th century railings in front of The Old House on Main Street. Plainer designs include the estate railings outside Woodland Cottage and the hoop railings at 3 Old Bakery Cottage.

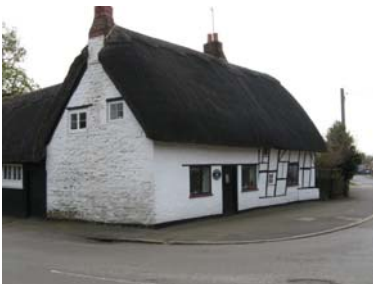
Grade II	Cottage. C17, of two builds. Right-hand half is timber framed with whitewashed plaster and brick infill and whitewashed stone plinth. Left-hand half is of brick with rubble stone to gable end, both whitewashed. Weatherboarded extension to rear along Main Street. Thatch roof, half-hipped to right, brick stacks to left gable and right of centre. One storey and attic. Left half has central door flanked by paired leaded casements, all under the same lintel. Right half has two small casements to left, one just below thatch, and paired leaded casement to right. Similar leaded casements to gable end.

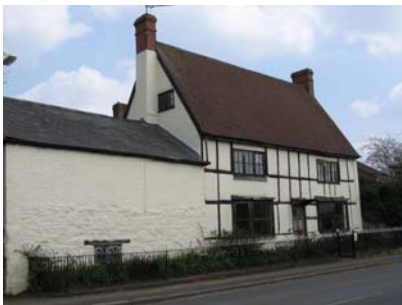
7	Scott's Farm, Towcester Road

Grade II	House. C18. Timber framed with regular rectangular panels of plastered infill. Steeply pitched tiled roof, flanking brick chimneys. L-plan. Two storeys and attic, two bays. Canted bay windows with C20 casements to ground floor, C20 3-light casements above. Paired casement to attic gable. Central panelled door, top-lyi, under wooden hood on cut brackets. Lower extension to left of brick and rubble stone, whitewashed, with slate roof and one low casement. Wing to rear has one and a half storeys.
8	Upper Farm, Towcester Road

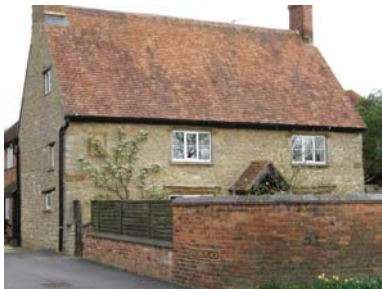
Grade II	House. Formerly dated 1624 on chimney stack. Coursed rubble stone, stone dressings, tiled roof, brick end stacks, that to left with thin brick at base. Two storeys and attic, two bays. C19 3-light wooden casements under flat stone hoodmoulds. Heads of three former mullions in each ground floor window. Worn 2-light stone mullion window with hoodmould to attic of right-hand gable. Central six panelled door with rectangular barred fanlight in panelled surround with timber gabled and tiled hood on brackets. Rebuilt wing to rear.

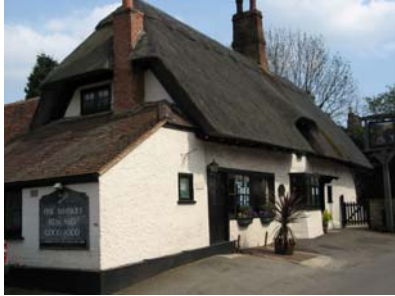
Grade II	Public house. C17. Timber frame exposed in right-hand gable end and one brace to right of front, remainder whitewashed roughcast. Half-hipped thatch roof, brick stack to right of centre with rebuilt base of thin bricks and lobby entry. One-and-a-half storeys, three bays. Left-hand bay has board door to left with two barred windows to right. Centre bay has C20 canted bay window to left and four panelled door under wooden hood on cut brackets with small casement to right. Right-hand bay blank. Small paired barred casement in thatch above centre bay. Right gable has canted bay window to ground floor and barred casement above. Tiled lean-to to left. Tiled brick and weatherboarded extension at right-angles to rear.
10	Pightle Cottage, Main Street

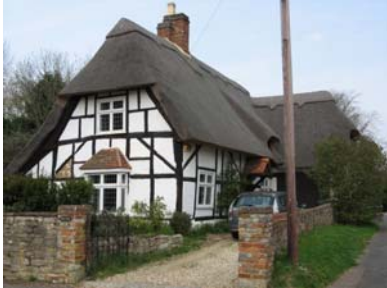
Grade II	Small house. C17. Timber frame with whitewashed brick infill. Half-hipped thatch roof, off-centre brick stack with thin bricks to base. One storey and attic. S.E. front of three bays at right-angles toroad. Leaded casements. Outer bays have cross windows. Off-centre modern board door with timber gabled and tiled hood on brackets, and small single casement to right. Right-hand bay partly obscured by modern extension at right-angles : white-washed brick with thatched roof and garage entry. Outshot to N.W. side. Street gable has square bay window to ground floor and cross window above.

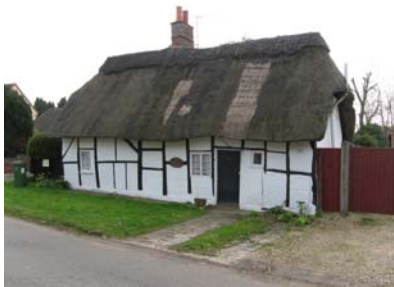
11	Old Pages Cottage, Main Street

Grade II	Cottage. C17. Timber frame with plastered panels and some whitewashed brick infill. Half-hipped thatch roof, brick stack to left of centre. One storey and attic, two-and-a-half bays. Barred casement to left, ledged door to right with paired C19 casement to left and small casement to right. Paired barred casements to ground floor and attic of left gable, attic casements to right gable and under thatch eyebrow to rear.
12	Chestnut Cottage, Main Street

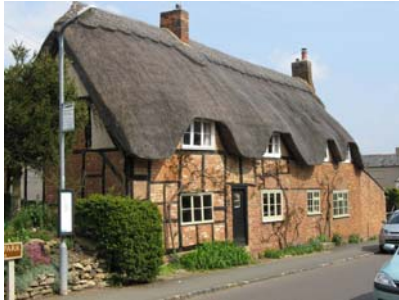
Grade II	Small house. C17, extended C18. Original cottage to left is timber framed with brick infill. Extension is of brick with timber lintels and framing under thatch eyebrows. Thatch roof over all, brick stacks to centre of cottage and right gable. One-and-a-half storeys, four bays. Left-hand bays have C19 3-light wooden casements with ledged board door between. Right-hand bays have C20 barred casements to ground floor, 2-light to left, 3-light to right, and paired C19 casements to first floor. Brick lean-to to right.

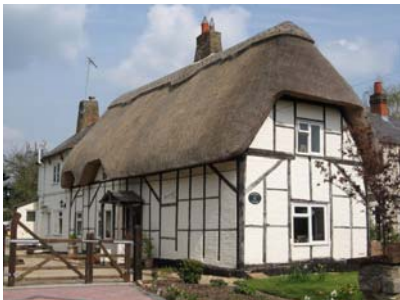
Grade II	Small house. C17. Timber frame, whitewashed brick infill, half-hipped thatch roof, off-centre brick stack. One-and-a-half storeys. Long irregular range with gable to street. Gable has C20 paired wooden casements to ground and first floors. N.W. side has two similar casements to left, one a single light, small casement in thatch, and central C20 door in brick and corrugated plastic porch. Early C19 whitewashed brick extension to north gable is of no special interest.
14	The Old House, Main Street

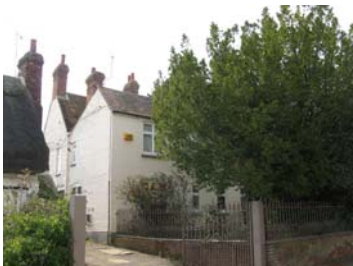
Grade II	House. Rear range late C17-early C18. Whitewashed rubble stone, brick to right-hand bay. Old tile roof, brick stacks to gables and between right-hand bays. Two storeys, three bays. C20 replacements of wooden cross windows. Lower left-hand bay has C19 canted bay window with French doors. Door between right-hand bays. Beam in upper room marked with Roman numerals. Modern brick range to front of no special interest.

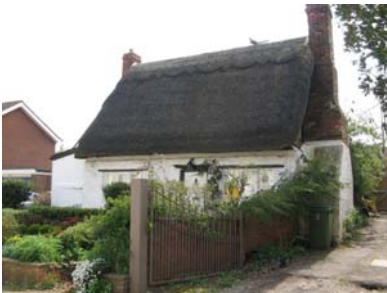
15	Old House Cottage, Main Street

Grade II	Cottage. C17-C18. Timber frame with plastered panels to rear and brick infill to left gable. Front of whitewashed rubble stone with brick eaves. Thatch roof with external brick end stacks that to right large. One storey and attic, two bays. C19 3-light casements under timber lintels to front, C20 barred casements to rear, one in thatch. Paired C19 casement to attic of left gable. C20 lean-to to left linking with C20 garage block.
16	Sideways Cottage, Main Street

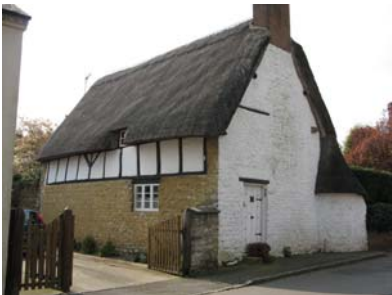
Grade II	Cottage. C17. Rubble stone to ground floor and colourwashed gable. Timber framed first floor with plastered panels. Thatch roof, brick stacks to street gable and external to right of N.W. side. One-and-a-half storeys, two bays. N.W. side has C19 casements to left, 3-light to ground floor, paired under thatch eyebrows, and central board door in moulded wooden frame. S.E. side has similar 3-light casement to right and paired casement in thatch above. Street gable has ledged board door to left and rounded thatched projection, probably an oven, to right corner.

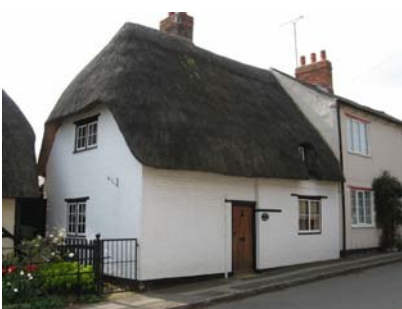
17	Myrtle Cottage, Main Street

Grade II	Cottage. C17, altered C19. Red brick, thatch roof half-hipped to left. Off-centre brick stack with lobby entry. One-and-a-half storeys, two bays. Paired barred casements with timber lintels to left gable and right-hand bay, upper window in thatch. Board door to left of centre, blocked door to right. Right-hand ground floor room has spine beam and stop-chamfered joists. At one time two cottages. Included for group value.

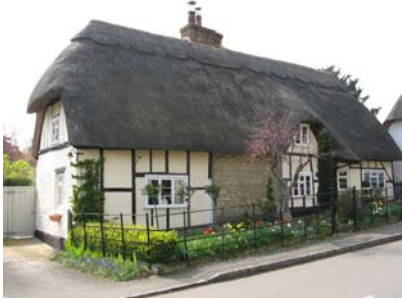
Grade II	Small house. C17. Timber frame with plaster panels, whitewashed rubble stone and some brick in gable end. Rubble stone chimney stack forms wall between left-hand bays, stack above partly of thin brick. Half-hipped thatch roof. One-and-a-half storeys, three bays. C20 wooden casements, 3-light to ground floor, paired to attic window under thatch eyebrow in central bay. Board door between right-hand bays has thatch swept down to form hood. single casement to right. Interior: has large open fireplace with carved wooden brackets above lintel.
19	Holly Tree Cottage, Main Street (formerly the old off-licence

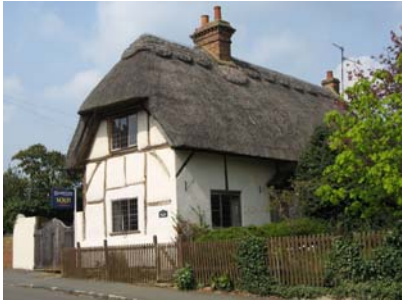
Grade II	Small house. C17. S.E. front has timber frame exposed in right-hand bay, remainder covered with pebbledash. Gable end to road rendered and colourwashed. Half-hipped thatch roof with rebuilt stacks to left of centre and right. One-and-a-half storeys, three bays. C19 3-light casements to gable end and ground floor left-hand bays, C20 paired casement to right. Right-hand bays have paired casements, leaded to right, under thatch eyebrows. Board doors between bays with flat wooden hood on brackets to left, and arched corrugated iron hood to right.

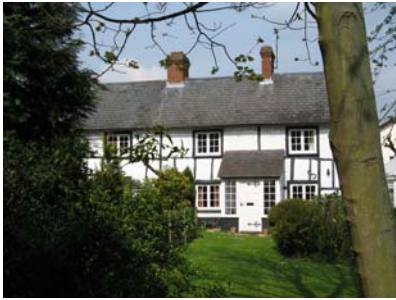
20	The Whitney Box and Whitney Box Cottage, Church Street

Grade II	Pair of cottages. C17 altered. Dated ICI 1700 on stone plaque re-set in gable. Timber framed with whitewashed brick infill and gable end, rendered plinth. Slate roof, two intermediate brick chimneys. Two storeys, three bays. Paired barred casements. Central bay has board door to right with rectangular barred fanlight. Entry to left hand cottage in gable. Right hand gable has cambered brick arches to door and first floor window. Lean to brick extension to rear

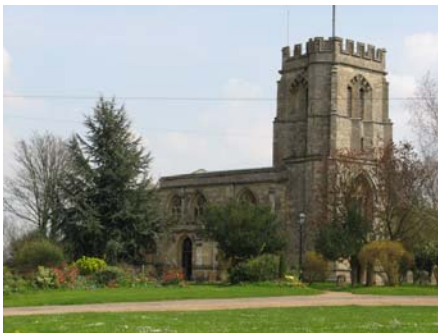
Grade I	<p>Parish Church. C15, restored late C19 and mid C20. Coursed rubble stone, lead roofs. Perpendicular. W. tower, nave, N. and S. porches, and chancel with 1882 vestry to S. W. tower: three stages, diagonal off-set buttresses, projecting stair turret to N.W. W. side has moulded doorway under battlemented canopy on fan supports, 4-light window above. Deeply recessed paired lights through top two stages with broad triangular mullions to centre and elaborately cusped single arch above. Battlemented parapet. Nave: has parapet, off-set buttresses and three bays of large transomed 3-light windows. N. porch has battlemented parapet with trefoiled panels, buttresses and corner gargoyles. Perpendicular arched doorway has 1637 door with carved panels and turned baluster ornament to tympanum and lintel. Interior: has two bays of fan vaulting on slim shafts, stone seats and C15 door with carved panels in double moulded arch, the outer arch cusped. S. porch has plain parapet with small central ogee niche and moulded doorway with carved angel heads to label stops. Fan vaulted. Chancel has wide 5-light E. window and 3-light windows to N. and S. N. side also has small moulded doorway and 2-light window to W. Interior: tower has fan vault on carved angel corbels. Nave has mullions continued below windows to form wall panels, stone seats, and tall recessed panels over doors. Tall moulded pointed arches to tower and chancel. Original roof, restored, with moulded beams, traceried spandrels and carved bosses. Chancel has similar wall panels and roof. Triple sedilia to S. wall has much restored elaborate canopy with ogee arches and finials, and painting of Last Supper on rear wall. C12 round font basin with scalloped ornament. C15 chancel screen with traceried panels and carved half-figures of angels at each end. Altar table 1623 with elaborately carved cup-and-cover legs. C18 bread box. Some C15 glass in top tracery panels of E. and W. windows. Remaining glass and fittings C19. C17 painted cartouche above N. door commemorating two daughters of Lord Peovre as founders of the church. 1890 replacements of brasses to the same below. Marble wall monument to Edward and Penelope Bate 1717 in chancel with Corinthian columns and open segmental pediment.</p>

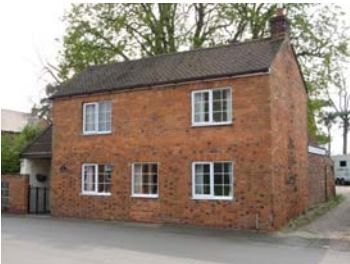
Local Note	Two storey brick cottage with tiled roof . Irregular fenestration. Modern windows. Despite modern alterations, in terms of form and scale is in keeping with historic neighbours. Positioned hard up to the carriageway, this building is prominent in the street scene and is important because it maintains a strong building line and reinforces the narrowness and enclosure of this section of Main Street.

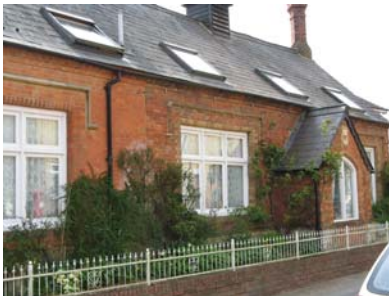
Local Note	19th century former school building. Red brick with some stone dressings. Single storey with slate roof and attractive chimneys. Mullion and transom windows sit beneath brick lintels. Converted to dwelling - insertion of roof lights. Sits front of plot behind low brick wall and railings. Prominent in street scene and maintains strong building line. Remains recognisable as former school despite conversion and makes positive contribution to both history of village and quality of streetscape.
33	Homestead, Main Street

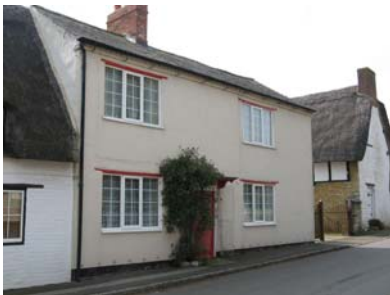
Local Note	Two storey building with narrow gable and shallow pitched slate roof. Rendered three light casement windows to ground floor, central chimney and slightly off centre doorway. In terms of scale and form is in keeping with neighbouring historic buildings. Situated hard up to back of pavement this building helps to maintain strong building line and reinforces narrowness of this section of Main Street. Prominent in street scene.

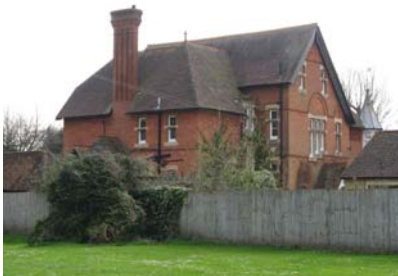
Local Note	19th century former rectory designed by well known local architect E. Swinfen Harris. Brick, two and a half storeys with steeply pitched tiled roof and prominent chimney. Irregular fenestration with stone dressings. Due to scale and situation close to the church it is a visually prominent building which makes a strong architectural statement and positive contribution to the character and appearance of the village.
